# Debugging a Mixed Signal Design with a Tektronix Mixed Signal Oscilloscope

## Introduction

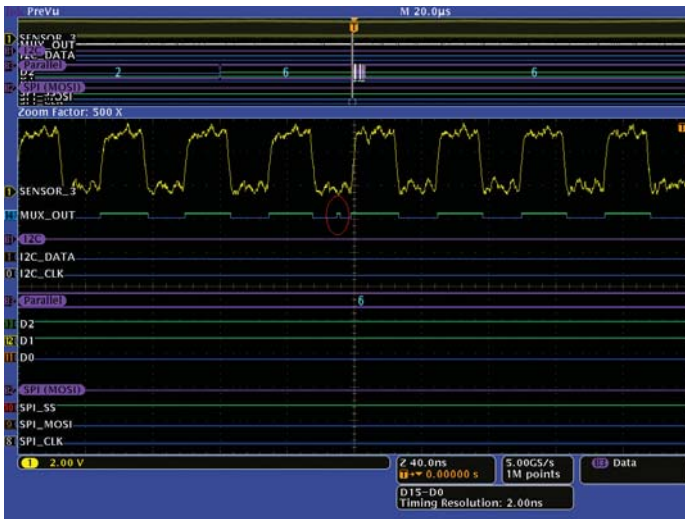
Figure 6. Wave Inspector<sup>®</sup> reveals a glitch on the MUX\_OUT signal.

Figure 6 shows the timing correlation between the analog and digital channels in the MSO Series. The input to the MUX is displayed on CH1 (SENSOR\_3) while the MUX output is observed on digital channel D14 (MUX\_OUT). The engineer noticed that although the MUX output had a glitch, the input to the MUX appeared glitch free. After identifying the glitch with the digital channel, the engineer decided to take a closer look by connecting CH2 to the MUX output. Figure 7 shows the resulting acquisition with the oscilloscope still configured to trigger on the parallel bus value 0x7. The waveforms for the

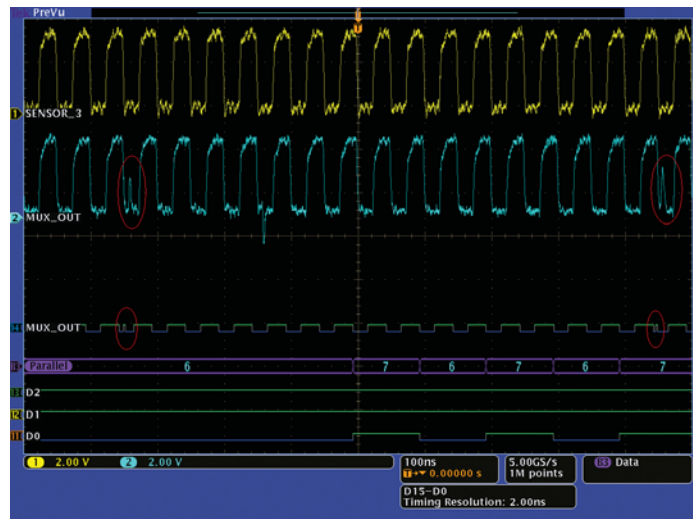
Figure 7. CH2 shows more detail for MUX\_OUT.

SPI and I<sup>2</sup>C buses have been turned off in Figure 7 to focus on the primary signals of interest. Using the analog probes on the MUX input and output revealed that glitches present on the output are not present on the input signal. Figure 7 shows that a glitch on the MUX\_OUT signal appeared a short time before the FPGA sent the error code. The timing relationship between these two signals indicated that the glitch could be the problem the engineer had observed. The engineer repeated the acquisition several times with the same configuration, and observed behavior similar to Figure 7 in every case.
